## Metallic artifact in MRI after removal of orthopedic implants

**Objective:** The aim of the present study was to evaluate the metallic artifacts in MRI of the orthopedic patients after removal of metallic implants.

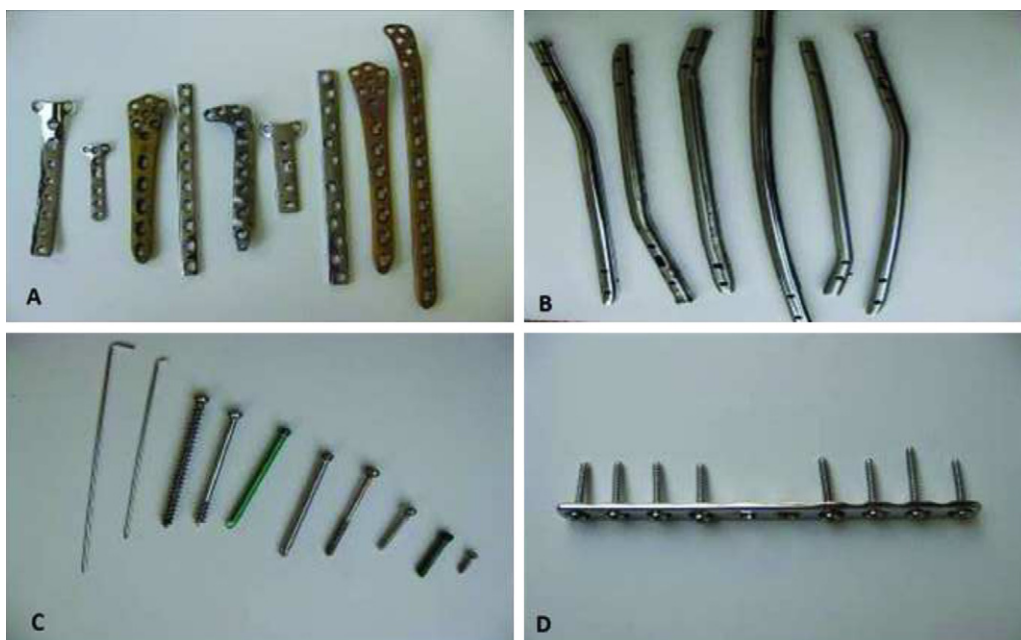
**Fig. 4.** Different types of removed metallic implants. (A) Plates (stainless steel and titanium), (B) intramedullary nails (stainless steel), (C) screws and pins (stainless steel and titanium) and, (D) an example of a plate with 8 screws (stainless steel) after removal from the site of implantation in the body.

In our cases different types of orthopedic implants were removed from the patients, such as plates, intramedullary nails, and screws and pins (Fig. 4).
